RT578_EN Rev.L

Error messages and troubleshooting for EIDOS Printers (valid for 5th generation and 6th generation)

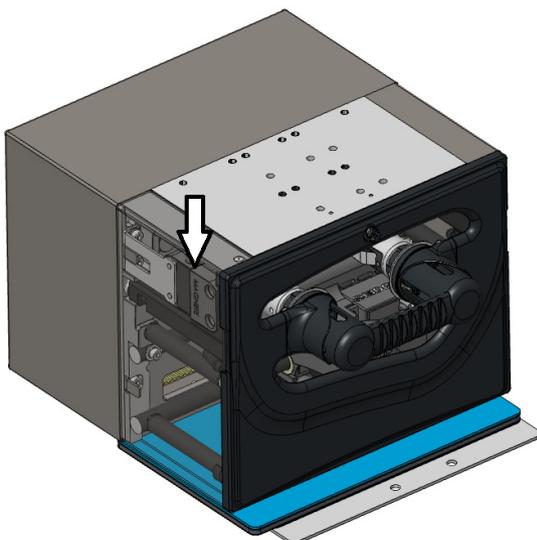
The error appears when the front cover is open or when the inputs "Safety Chan-A" and or "Safety Chan-B" on DSUB-25 I/O SIGNALS connector are open.

When the cover has been closed the printer makes a ribbon rewind operation and a carriage home-service-home search.

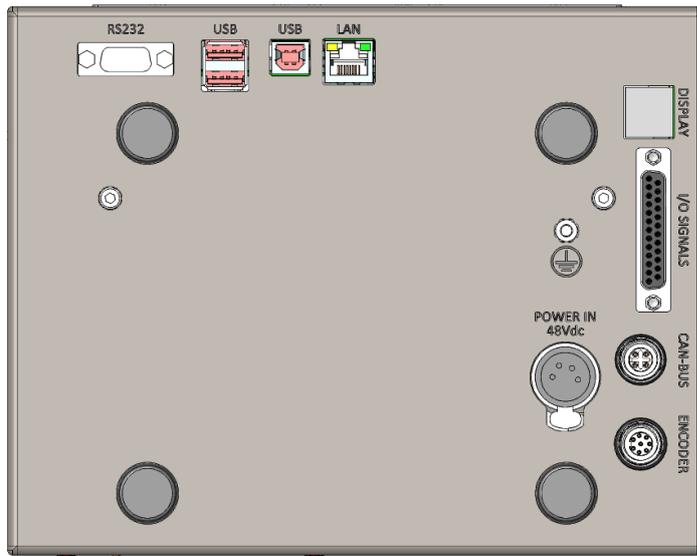
If there are no external safety contacts, "Safety_Chan-A" and "Safety_Chan-B" must be joint together and with "Safety-COM": join pins 5 – 18 – 6 on I/O SIGNALS connector.

D-Sub 25P MALE	
OUTPUT - FAP	1
OUTPUT - RIS	14
OUTPUT - ANM	2
OUTPUT - RDY	15
OUTPUT - LABEL RDY	3
COM OUTPUT	16
	4
	17
INPUT SAFETY CHAN-A	5
INPUT SAFETY CHAN-B	18
INPUT SAFETY COM	6
	19
INPUT - RST	20
INPUT - STB	8
INPUT - C2S	21
INPUT - STA	9
COM INPUT	22
	10
	23
INPUT - PG0	11
INPUT - PG1	24
INPUT - PG2	12
INPUT - PG3	25
COM INPUT PG	13

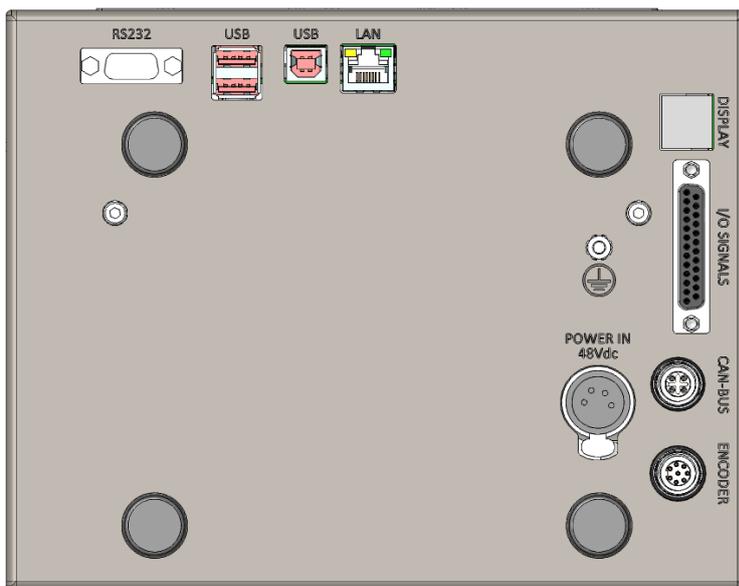
- The INPUT-RST on I/O SIGNAL DSUB 25 connector has been activated.
- When the input is deactivated the error disappears while a ribbon rewind and carriage home search functions are made.

D-Sub 25P MALE	
OUTPUT - FAP	1
OUTPUT - RIS	14
OUTPUT - ANM	2
OUTPUT - RDY	15
OUTPUT - LABEL RDY	3
COM OUTPUT	16
	4
	17
INPUT SAFETY CHAN-A	5
INPUT SAFETY CHAN-B	18
INPUT SAFETY COM	6
	19
INPUT - RST	20
INPUT - STB	8
INPUT - C2S	21
INPUT - STA	9
COM INPUT	22
	10
	23
INPUT - PG0	11
INPUT - PG1	24
INPUT - PG2	12
INPUT - PG3	25
COM INPUT PG	13

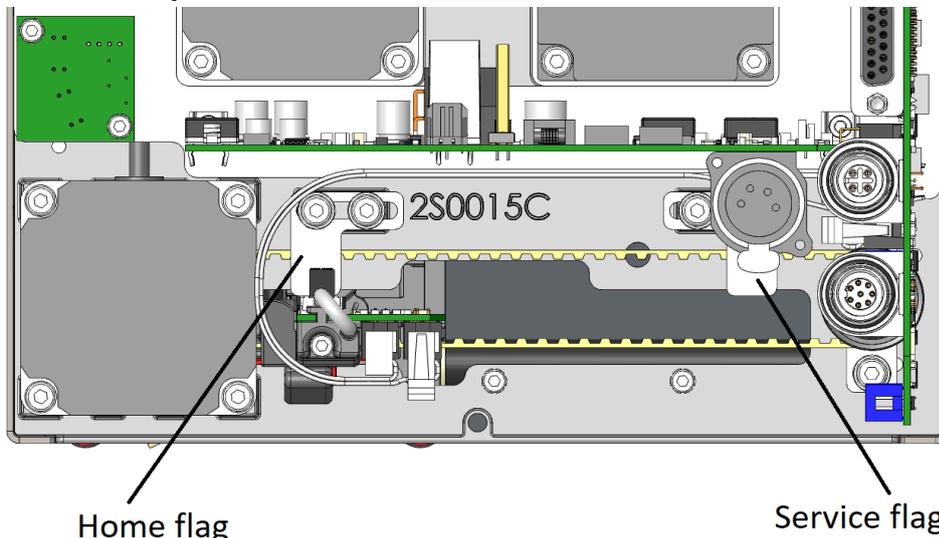
For XTO-LH printers

- The home sensor has not detected any signal variations.
- Check the sensor and relative connection and cable.
- Check manually the carriage movement in the complete stroke.
- Check the step motor carriage: there could be too high backlashes on the pulley driving.
- Check the belt tension and the status of the teeth.

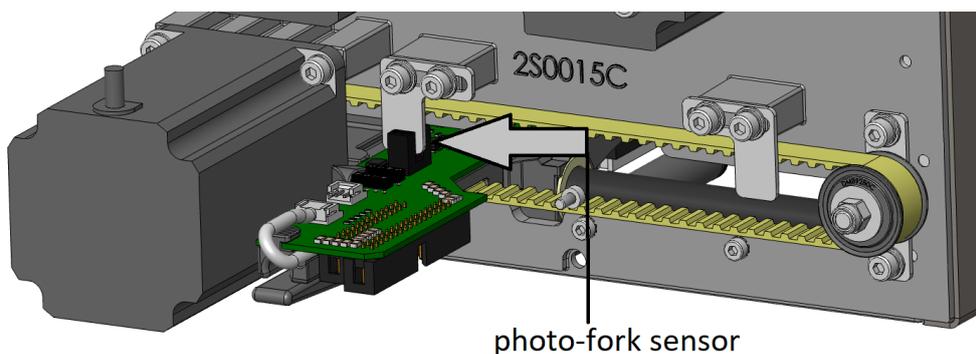
Home-Service position photo-fork sensor:

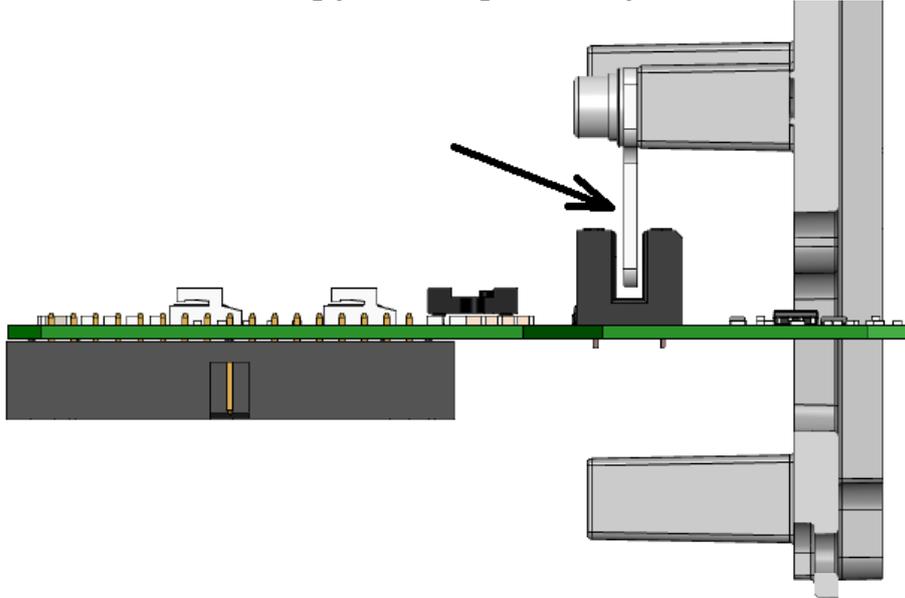
Home – Service metal flag positioning than the photo fork sensor

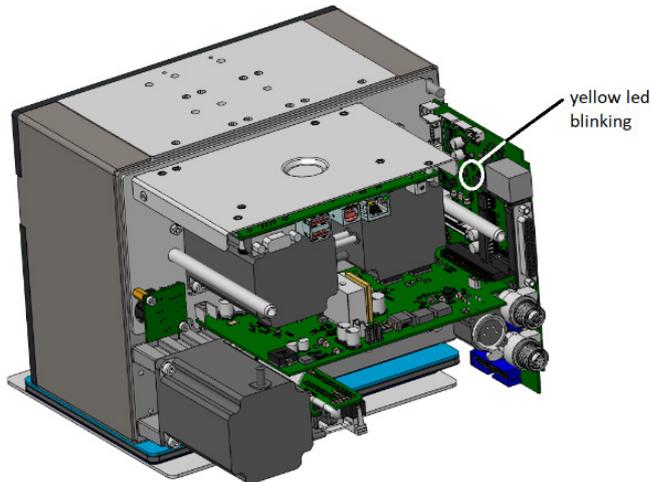
- check if on the SIB01 interface board there is a flashing yellow LED in the upper portion (area above the Power Board); it means the KV11 processor is active.

- check the connections relating to the 45CV882 / 1 cable (ref. to DEB9009 electrical diagram) which connects the J1-CAN connector on the 43SIB01 interface board with the CAN-2 connector on the CPU and the J4 connector of the 43SPB01 Power board.

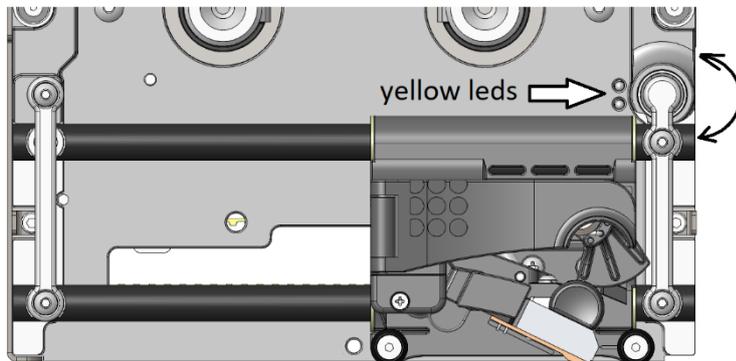
Rotate the encoder manually and check if the yellow leds lit up during rotation.

The led 1 – led 2 sequence during rubber roll rotation must be:

“00, 01, 11, 10” four times every 360 degrees of roll turn.

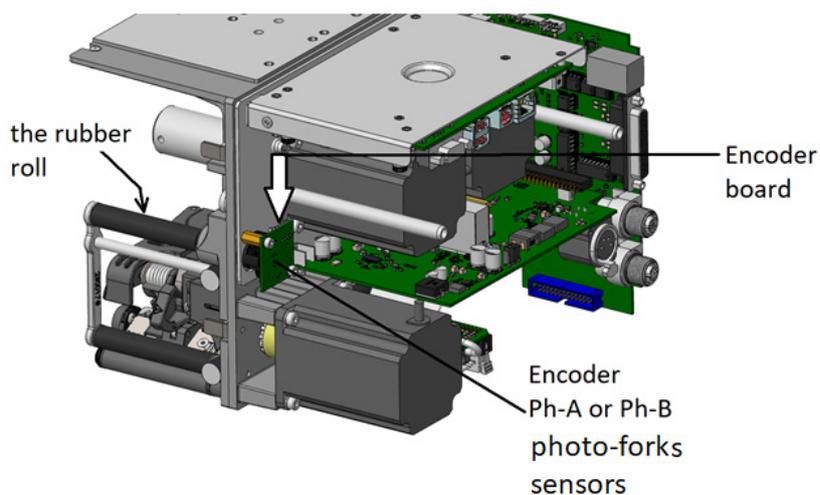
There could be a hardware problem on the encoder board or on the 45CV867/1 cable that connect the Encoder Board to J9 connector of the Interface Board.

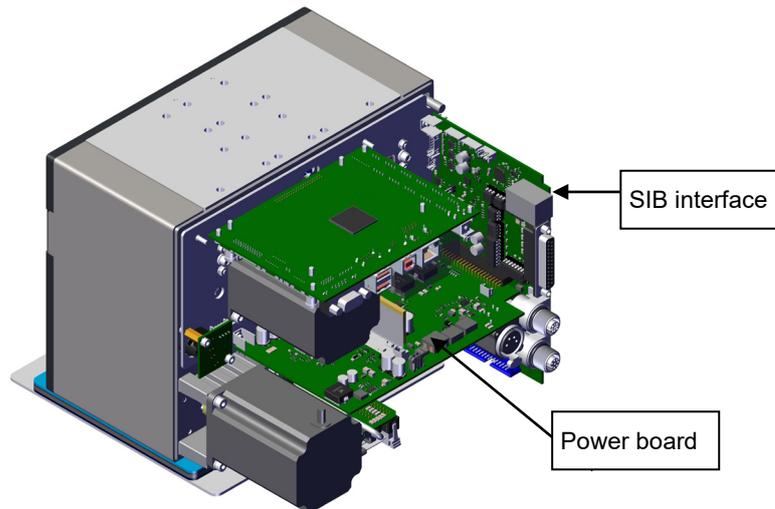
Check the connections relating to the 45CV882/1 cable which connects the J1-CAN connector on the 43SIB01 interface board, the CAN-PWR connector on the CPU board and the J4 connector of the 43SPB01 Power board.

Ref. to DEB9009 electrical block diagram for XTO2i and to DEC1018 electrical block diagram for XTO2i.nn for internal connection.

Check also that the KV11 processor on the SIB interface board is running (the yellow led is blinking)

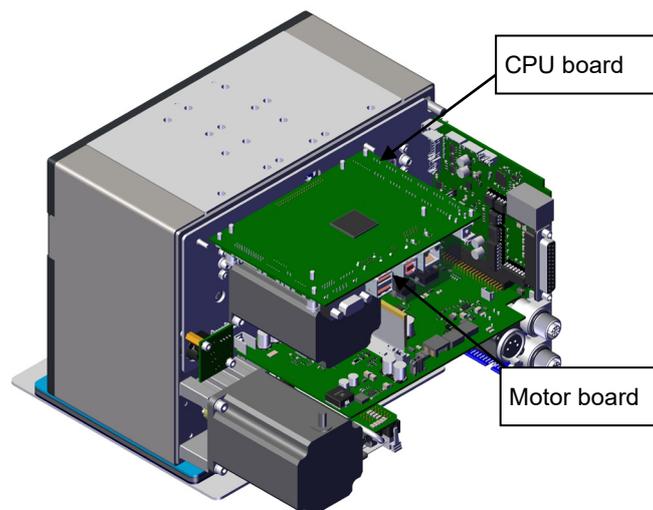
Check the connection between the CPU and the Motor Board (the Motor Board is screwed to the CPU by means of 4 screws; check they are well screwed).

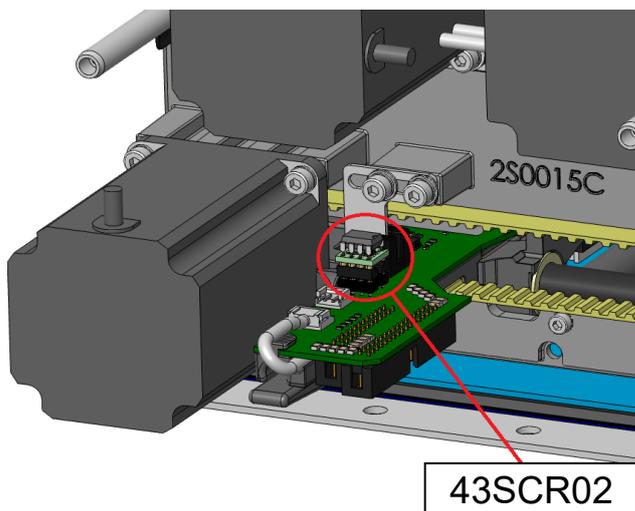
Check the 43SCR02 board presence and correct insertion on the Carriage board.

Warning: if the 43SCR02 board is inserted opposite in the 8 dip socket, it will be irreparably damaged and it must be replaced.

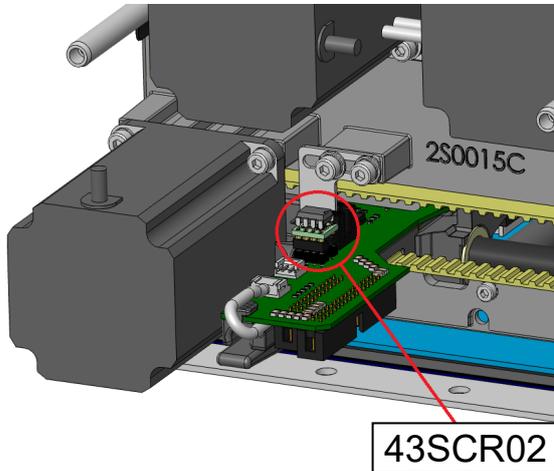
The Eeprom memory does not work properly. Change the 43SCR02 board.

Warning: if the 43SCR02 board is inserted opposite in the 8 dip socket, it will be irreparably damaged and it must be replaced.

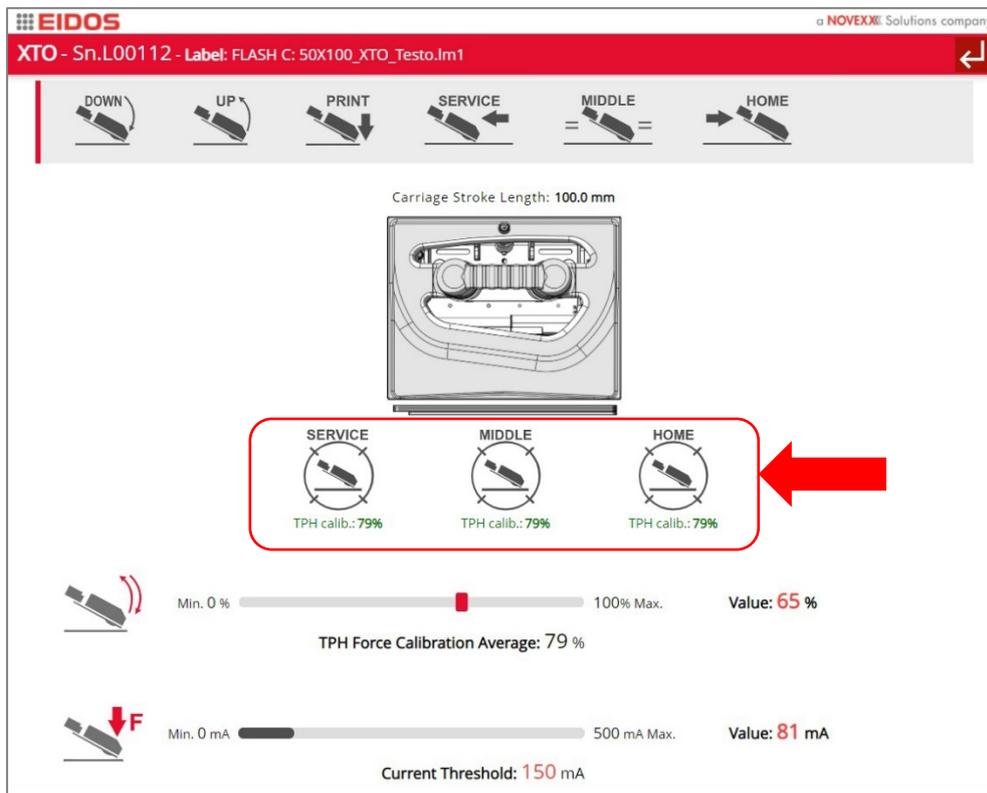
This error happens when the ribbon release coil rotates when the printer is not in cycle. It means that the ribbon is fed by the packaging film during movement in the next position. Check the print-head's calibration or the distance between the print head and the print plate.

The TPH calibration function detects the distance between the print head and the rubber plate when the carriage and set the best advised TPH FORCE value in term of head pressure on film. The advised values as calibration results are in the range 74 – 80% (best for us is 75-76%).

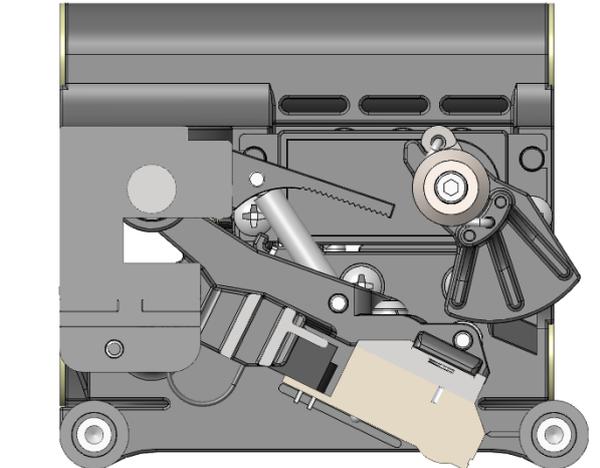
This error appears when the servomotor current absorbed is $> 3A$ for 6 seconds. Open the cover and rotate manually the servo cam in the direction to push down the print head. Try to rotate manually the servo cam in alle the rotation range to check if the gears are locked.

The servomotor moves the print head toward the print plate or print roller by rotating a cam that has a specific profile. A spring returns back the head to home.

The cam can assume different angle depending by the servomotor % of rotation in a range between 0 to 100%.

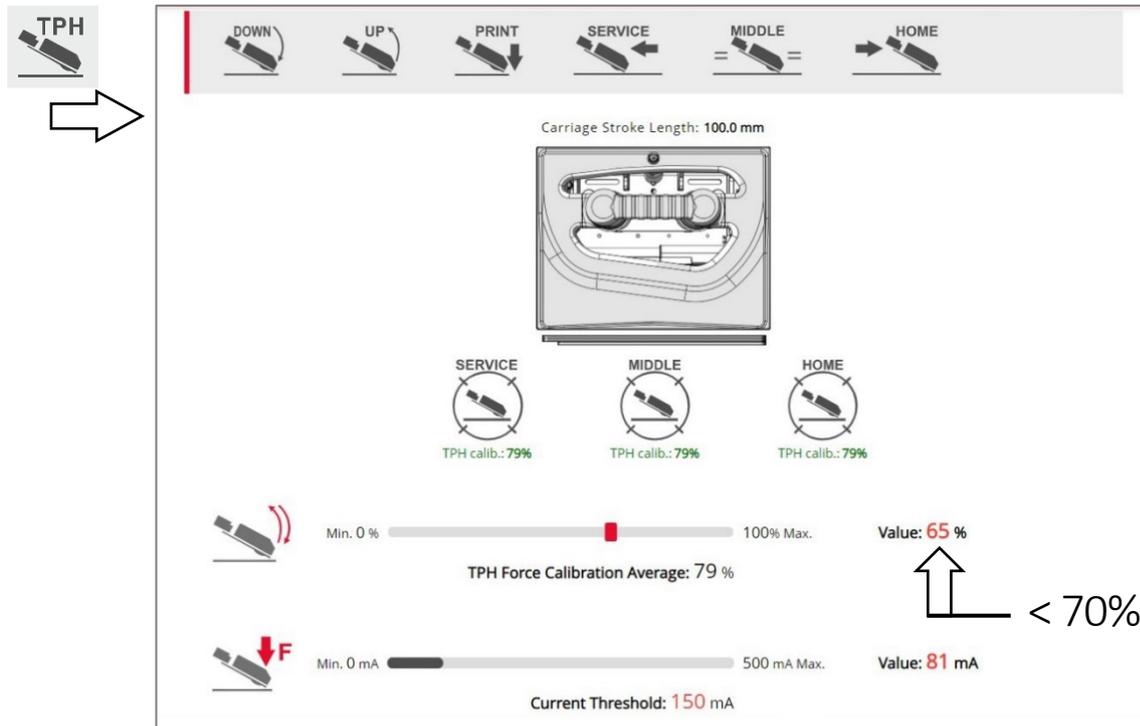
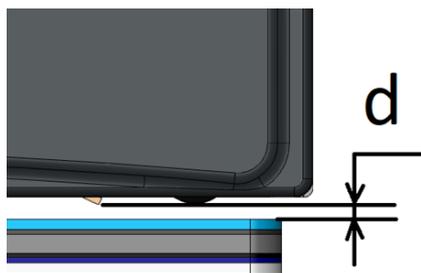
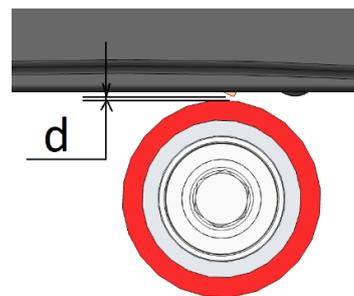
It means that the print rubber plate (XTOi) or the print rubber roll (XTOc) is too close from print head dot line. The distance between print head and print rubber plate or print rubber roller must be increased.

Optimal is to get a Calibration value in the range 74 – 76%, with distance “d” around 1 – 1.5 mm.

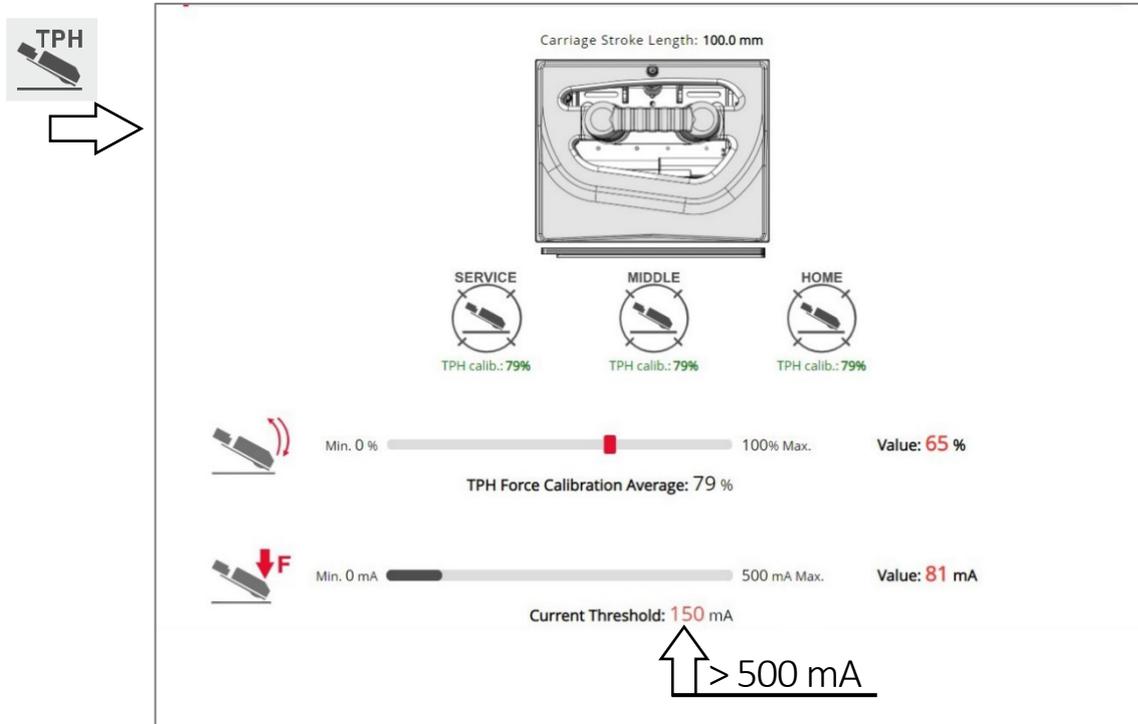
This warning appears when after a TPH calibration the detected “Current Threshold” value is out of range (greater than 500 mA).

It means that the print rubber plate (XTOi) or the print rubber roll (XTOc) is too close from print head dot line. The distance between print head and print rubber plate or print rubber roller must be increased.

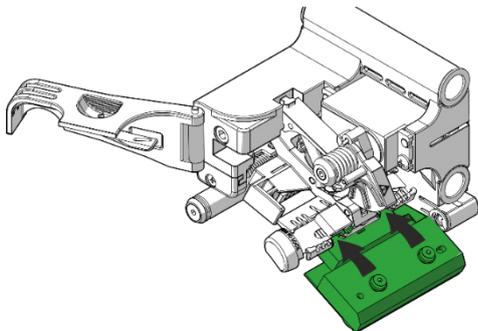
Check that the print head is mounted correctly.
